January 2014 Technical Service

This Service Information bulletin supersedes SI B11 04 13 dated November 2013

Service Action: N14 Engine Check Timing Chain Tensioner and Timing Chain

With the N14 engine

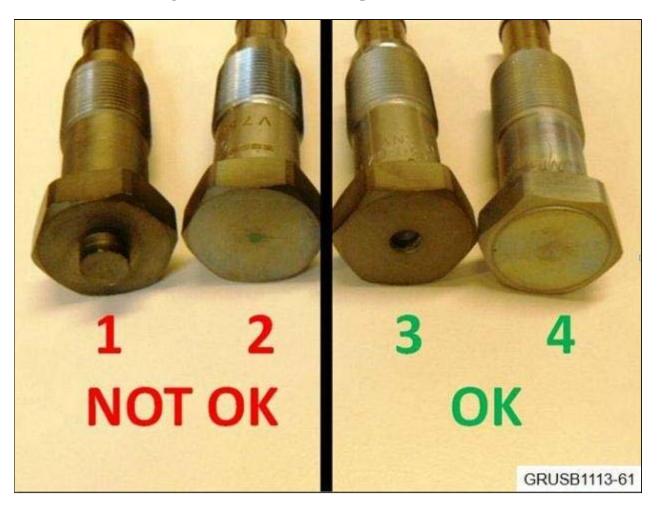
The timing chain tensioner applies pre-tension to the timing chain guide rail mechanism. In some cases, the tensioner spring force may be too low. Depending on the severity of the wear, it may lead to a rattling noise when starting the engine cold or when the engine is idling.

The timing chain tensioner internal tolerances are not consistent.

Item 1: Protruding boss – Not OK	Item 3: Drilled head – OK
Item 2: Flat head, no markings, no holes, no machined edge – Not OK	Item 4: Machined edge in head – OK

- 2. New If the engine is fitted with a timing chain tensioner that has a drilled head (item 3) or has a machined head (item 4), do not replace the timing chain tensioner. No further repairs are needed. If the chain tensioner has a protruding boss (item 1) or a flat head (item 2), proceed to step 3.
- 3. Remove the right-hand wheel arch trim to access the crankshaft central bolt.
- 4. Disconnect the battery and remove the ignition coils and spark plugs. Turn the engine in clockwise direction by hand to move the flywheel approximately 90° before TDC. Rotating the engine counterclockwise may cause an incorrect measurement.

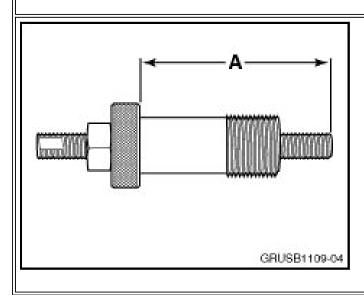
7. Remove chain tensioner
Special Tool 11 9 340 from the engine, with the lock nut still tight. Measure the distance
(A), as described in the illustration.

- 8. If distance A is less than 68 mm, replace the chain tensioner with sealing ring P/N 11 31 4 609 482 (refer to parts list A).
- 9. If distance A is 68 mm or greater, replace the components below, found in the Timing Chain Repair Kit P/N 11 31 8 623 601 (refer to parts list B):
  - o Timing chain tensioner
  - Sealing ring
  - o Timing chain
  - o Guide rail
  - o Tensioner rail
  - o Sliding rail
  - Sprocket on the crankshaft
  - o Bearing bolts for the tensioner and guide rails
